Maintenance Manual

Series 860 Reduced Pressure Zone Assemblies Models 860, LF860, 860U & LF860U 1/2" - 2" (15 – 50mm)

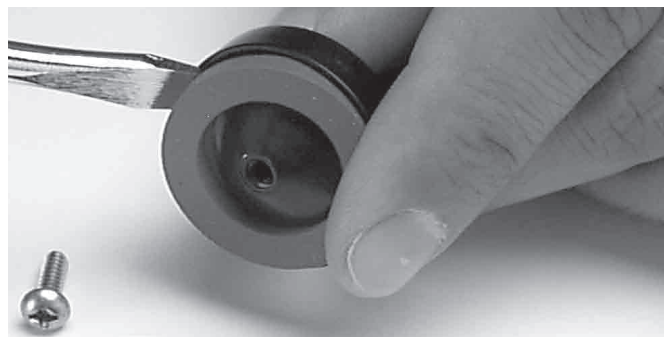
2. Remove retaining screw (Item 5.2) and disc retainer (Item 5.1) so the rubber disc is fully exposed. Carefully pry out the rubber disc from poppet. Be careful not to damage the poppet when removing the disc. Rinse poppet in clean water and replace the old rubber disc with new rubber disc. If the rubber disc is not damaged, it can be reversed and reinstalled when a new disc is not available. Rinse all other internal components with clean water. Replace disc retainer and secure with retaining screw (Item 5.2).
